**UNDERWATER FACILITIES
INSPECTION AND ASSESSMENT
AT**

**NAVAL SUBMARINE BASE
SAN DIEGO, CALIFORNIA**

FPO-1-82(17) SEPTEMBER 1982

**COLLINS ENGINEERS, INC.
600 WEST JACKSON BOULEVARD
CHICAGO, ILLINOIS 60606**

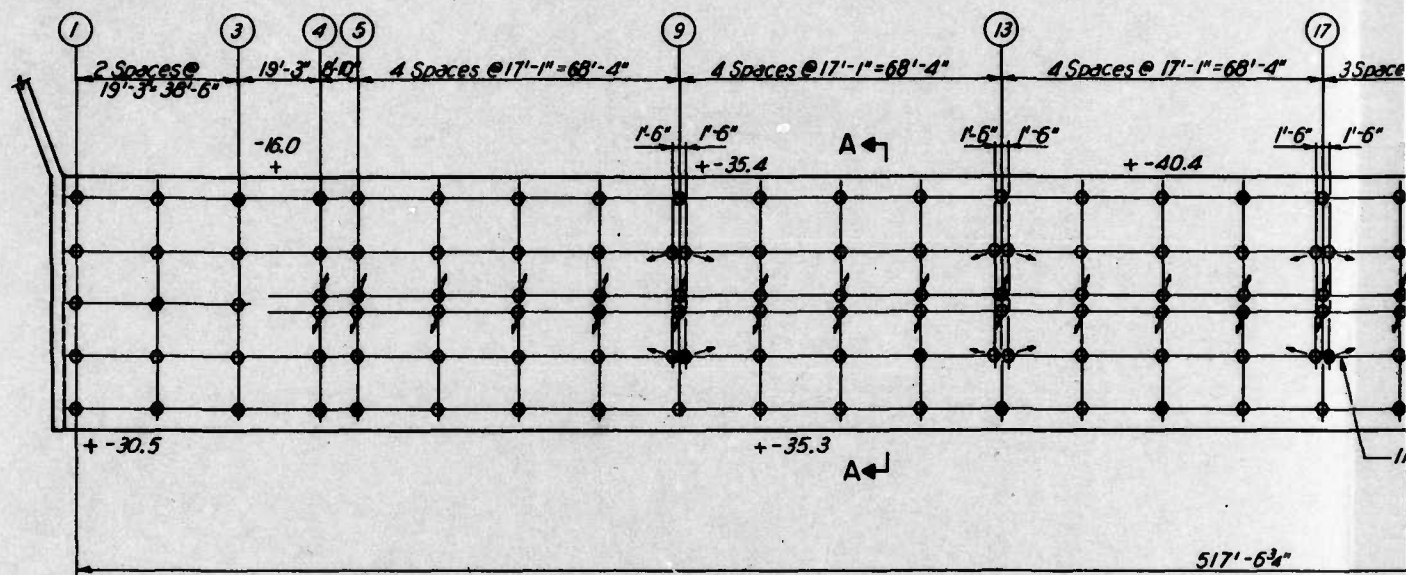
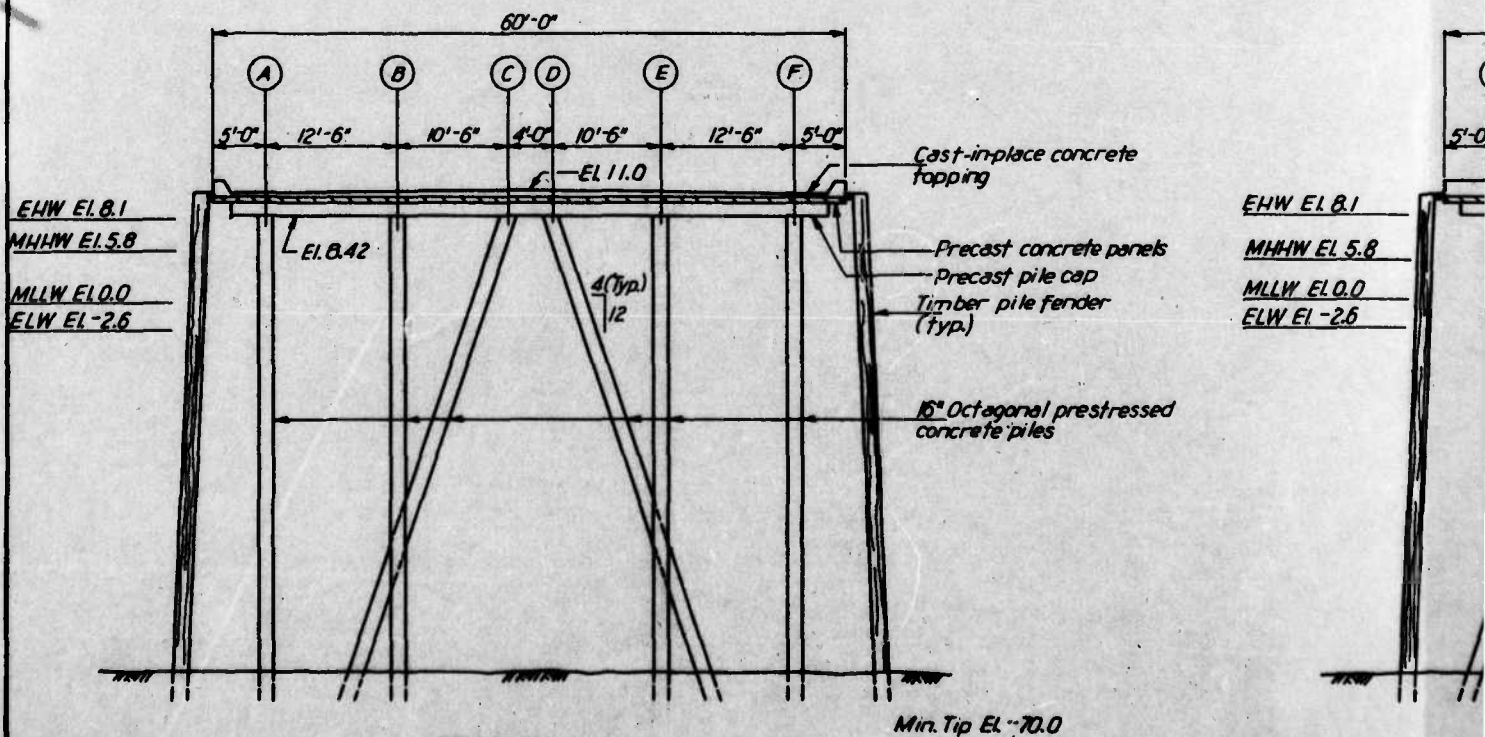
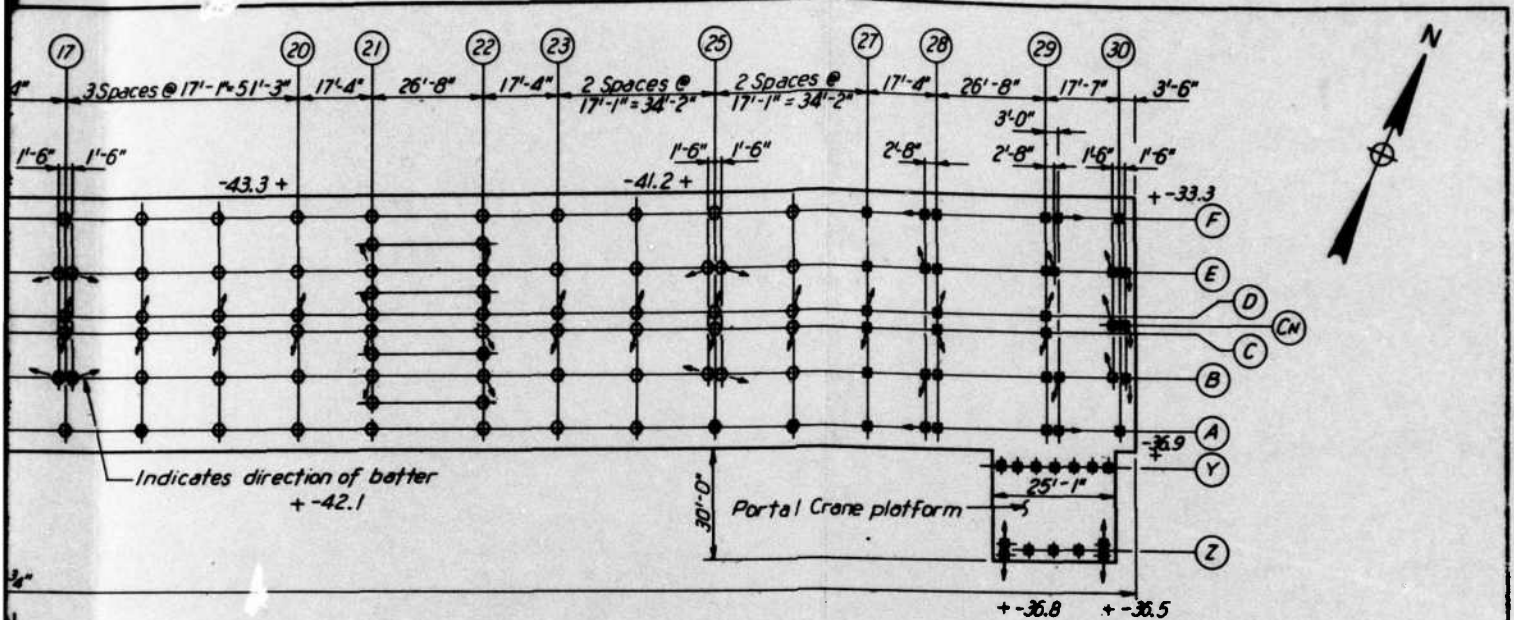
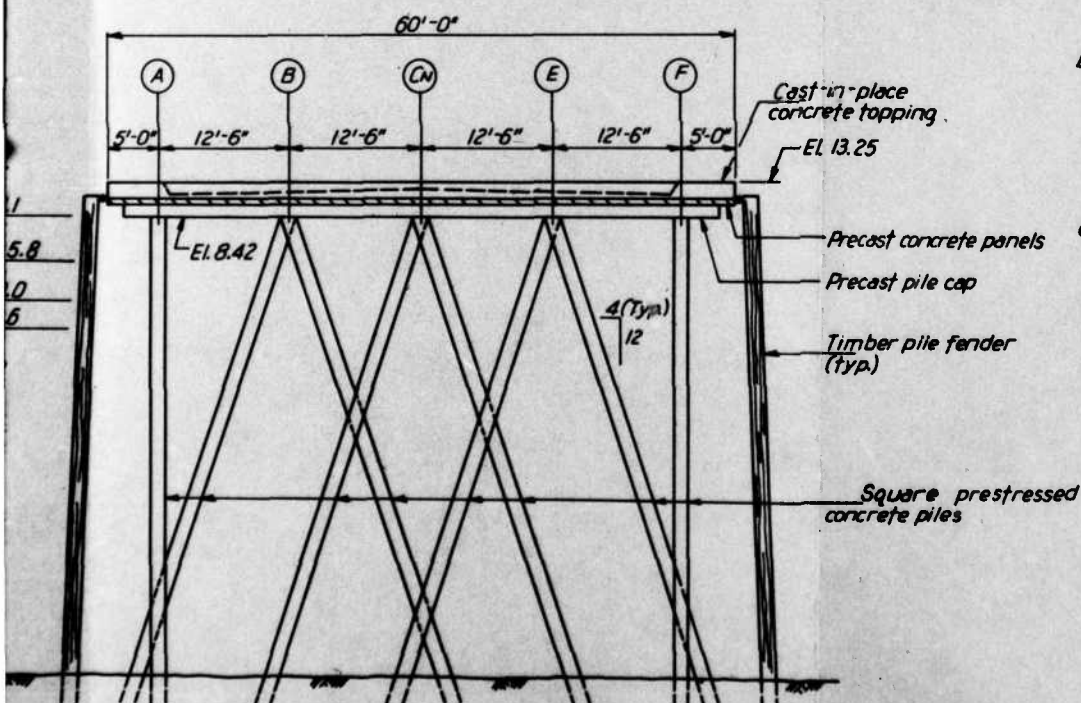
Pier 5003 is in excellent condition. No significant distress or deterioration was found.

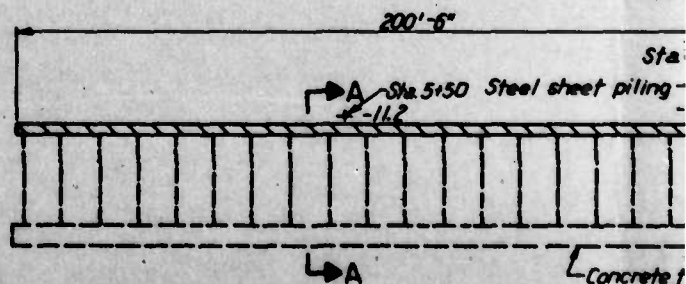
TYPICAL STEEL SHEET PILE-MZ-27"

The remaining section of six steel sheet piles was measured ultrasonically. Refer to Figure 7 for the detailed measurements. In general, the thickness of the steel sheeting is greater than or approximately the same as the theoretical

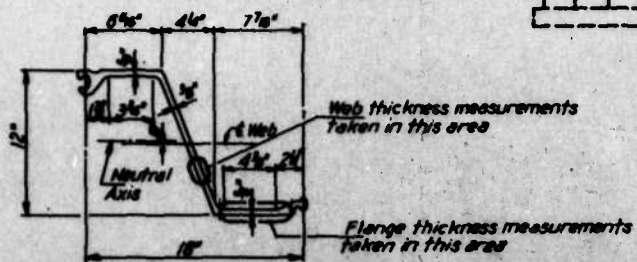
TYPICAL STEEL SHEET PILE-MZ-27 *

The remaining section of six steel sheet piles was measured ultrasonically. Refer to Figure 7 for the detailed measurements. In general, the thickness of the steel sheeting is greater than or approximately the same as the theoretical thickness of the pile.
